Manhole Inspection Summary

Manhole # S33GG_005MH

Location Address: **MT ROYAL AVE** Cross Street: **MARYLAND AVE**

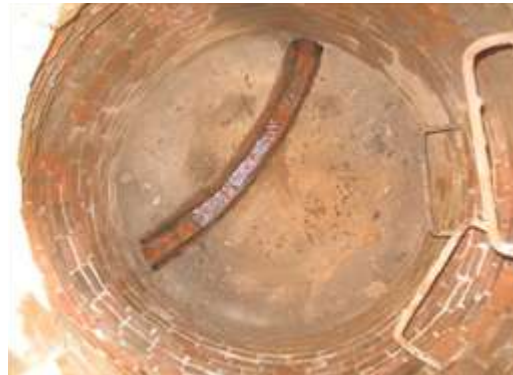
Top View

Bench debris.

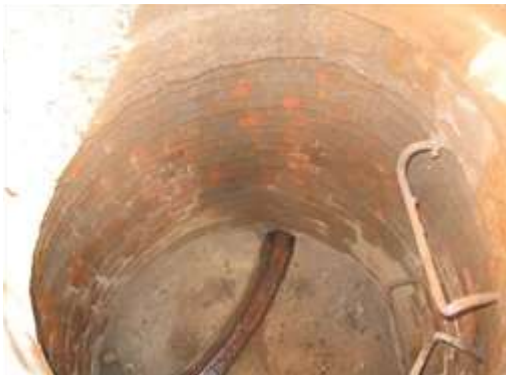
Defect

Frame leaks. Adjustment and Barrel infiltration - other side.

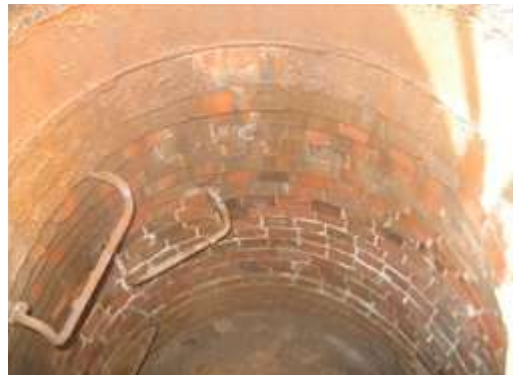
Defect

Frame leaks. Adjustment and Barrel infiltration.

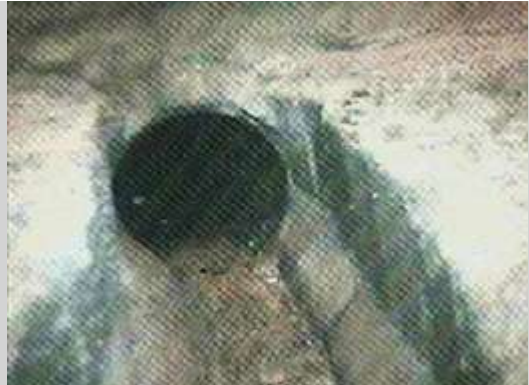
6 in. Circular Gravity Sewer Pipe Out @ 12 O'Clock

Deposits: ☐ None ☒ **Mud** ☐ Sludge ☒ **Debris** ☐ Grease

Silt Depth: **0.5** (in.) Deposits Extent: **Light**

Infiltration: **Evidence** Pipe Seal Cond: **Unknown**

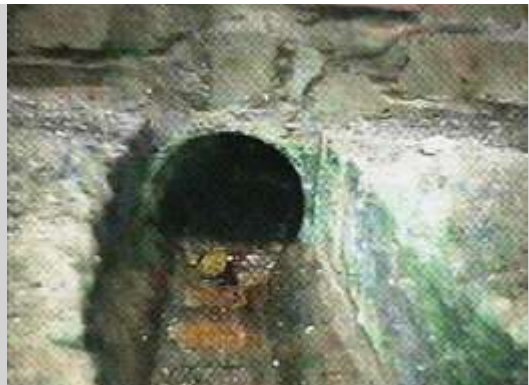
6 in. Circular Gravity Sewer Pipe In @ 8 O'Clock

Deposits: ☐ None ☒ **Mud** ☐ Sludge ☒ **Debris** ☒ **Grease**

Silt Depth: **0.5** (in.) Deposits Extent: **Light**
